August 23, 2019

Subject: Polychlorinated Biphenyl (PCB) Substrate Testing
CONCRETE - POST VISUAL CLEARANCE
South Wall Building 15

Site Address: Rainier Commons, LLC
3100 Airport Way S, Seattle, WA

NVL Project#: 2012-494

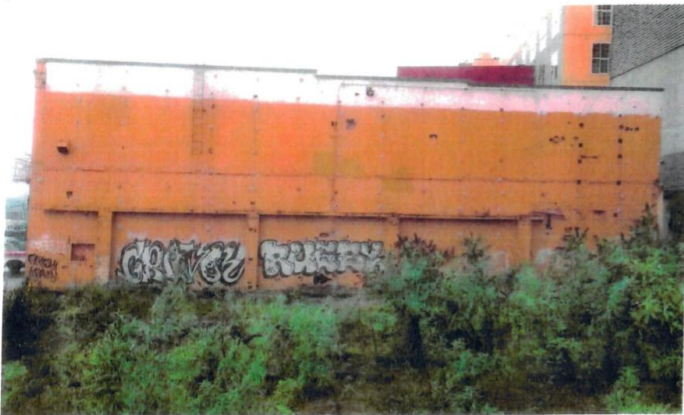
1

<p>Building 15, South Elevation</p>	<p>Building 15, South Elevation prior to abatement</p>
2	<p>BUILDING 15, SOUTH ELEVATION CLOSE-UP (PRE-ABATEMENT)</p>

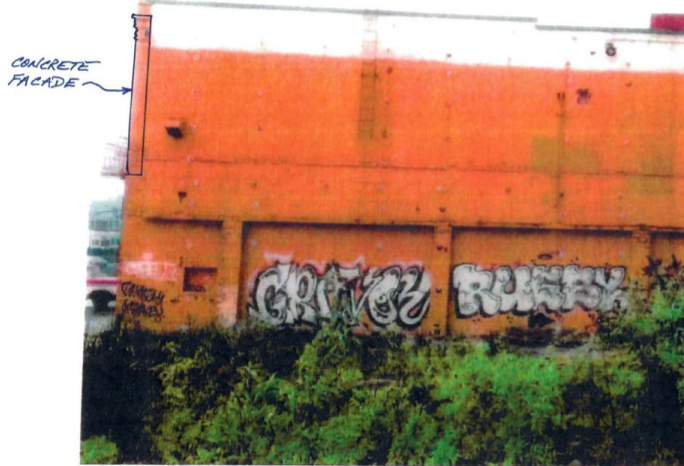
3

<p>CONCRETE FACADE</p>	<p>Building 15, South Elevation Pre-Abatement</p> <p>Close-up</p> <p>Showing location concrete facade</p>

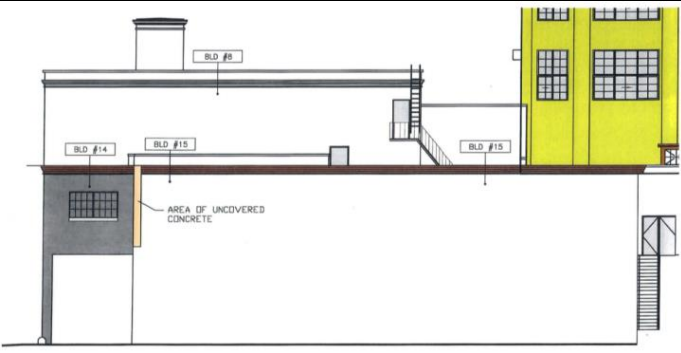
Diagram Showing Concrete Area South Elevation Building 15
4

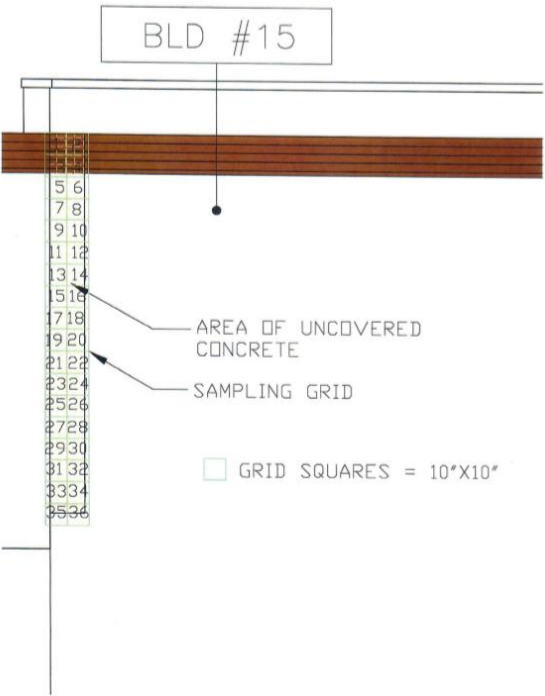
Assigning Grid Identification on Close-Up Cut-Out of Concrete Area South Elevation Building 15 Grid locations #1 to #36

Once this grid pattern system was established, the sampling locations were selected using the random number generator at www.random.org.

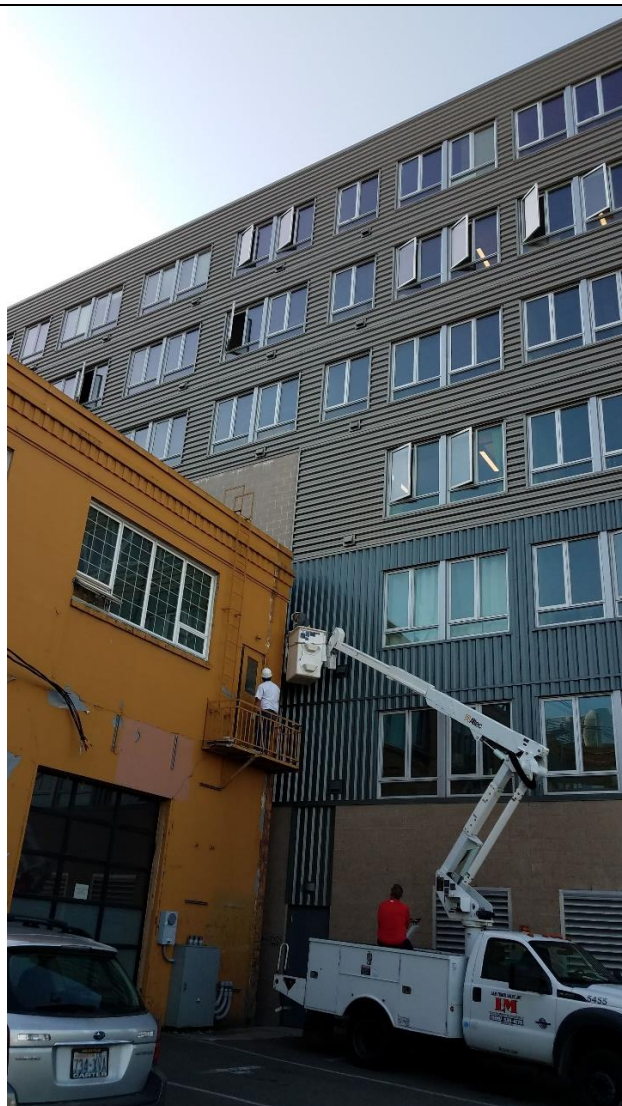
1

Access to the Concrete Area on the South Elevation of Building 15

Safe access to the concrete area on Building 15 where testing took place was challenging due to the fact that a new building, which can be seen in the photograph, was constructed less than two feet immediately adjacent to the south elevation exterior wall since the time paint abatement occurred in 2016.

Given the field conditions, proper and legal use of a ladder to access the testing area in the very tight space could not be achieved.

As a result, a bucket truck aerial lift was obtained and used to gain correct access to the limited area.

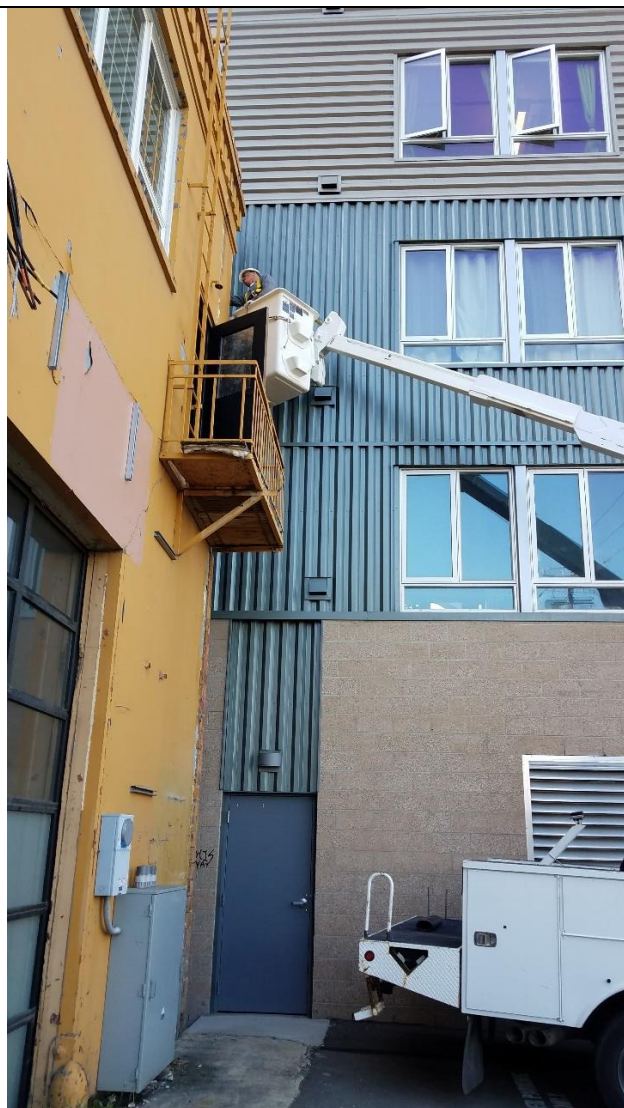
2

Bucket Truck Aerial Lift In Use

The photograph shows that access into the space between the two buildings to collect the sample was limited.

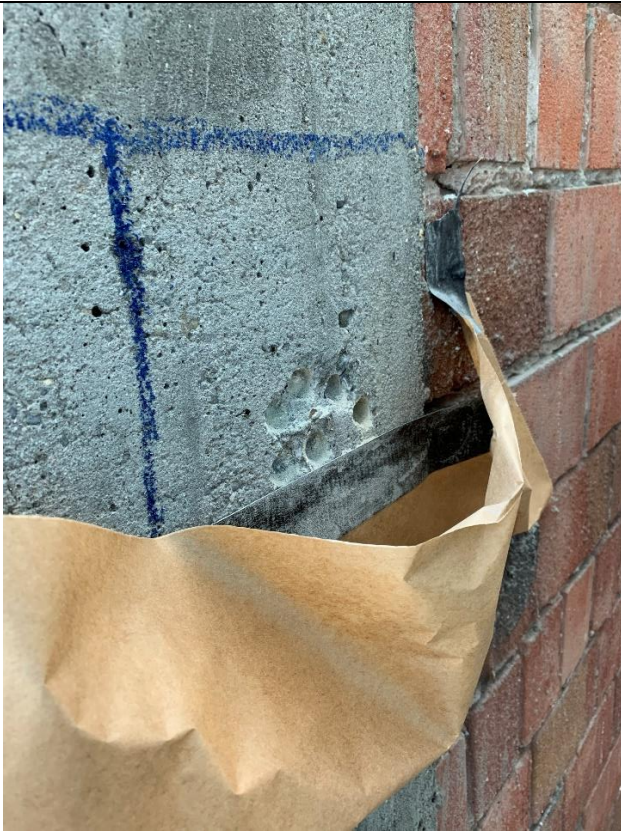
3

<p>Typical example of Testing</p> <p>Blue lines are from layout of sampling grid pattern.</p> <p>Surface debris was removed using a clean brush and cloth prior to drilling.</p> <p>Samples were collected using an impact hammer drill with a 5/8 inch concrete drill bit to generate a uniform, finely ground powder. Depth was controlled to be no more than one half inch by marking the depth with tape on the drill bit.</p> <p>The brown paper was taped to the wall to collect the sample material.</p>
---	--	--
